Manhole Inspection Summary

Manhole # S21W__017MH

Insp Date: **5/14/09 4:46 PM**

Location Address: **2211 BERLIN ST.**

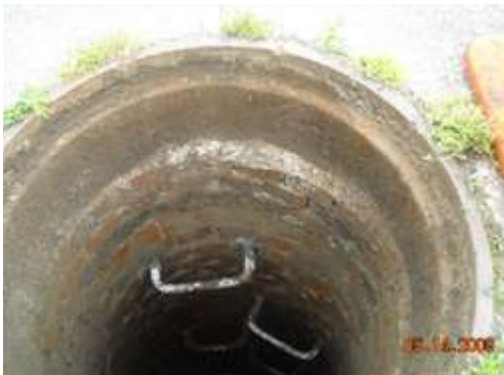
Defect 2

Frame Offset: **3** (in.) Condition: ☒ Sound ☐ Cracked ☐ Leaks

FRAME OFFSET

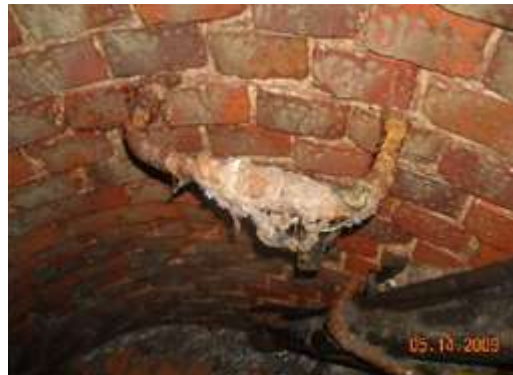
Defect 1

Steps Count: **8** Missing: **0** ☒ Corroded

Surcharge ☒ Evidence Of Surcharge Depth: **4** (ft.) ☐ Active Surcharge Present

CORRODED STEPS; EVIDENCE OF SURCHARGE

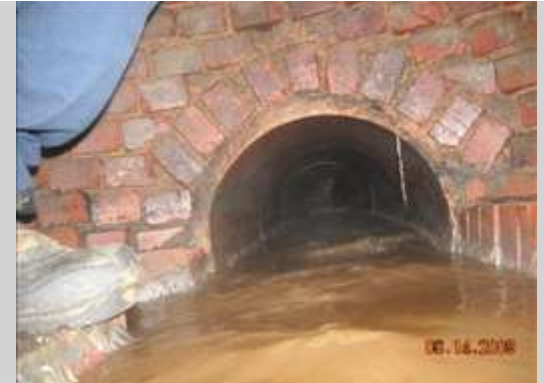
12 O'Clock Outflow

18 in. Circular Gravity Sewer
Pipe Out @ 12 O'Clock

Pipe Height: **18** (in.) Rod and Bar (Angled)
Pipe Material: **Clay** ☐ Pipe Lined
Invert Depth: **14.10** (ft.) Flow Characteristics: **Slow**
Deposits: ☒ None ☐ Mud ☐ Sludge ☐ Debris ☐ Grease
Silt Depth: **0** (in.) Deposits Extent:
Infiltration: **None** Pipe Seal Cond: **Sound**

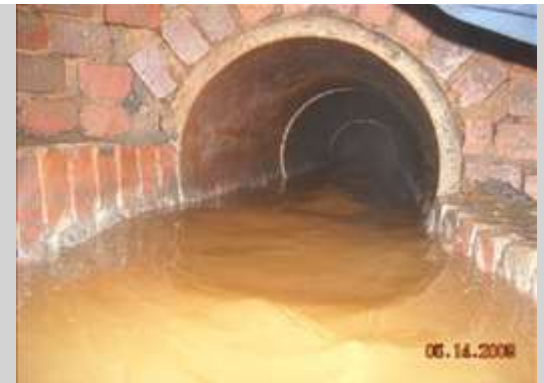
7 O'Clock Inflow

18 in. Circular Gravity Sewer
Pipe In @ 7 O'Clock

Pipe Height: **18** (in.) Rod and Bar (Angled)
Pipe Material: **Clay** ☐ Pipe Lined
Invert Depth: **14.00** (ft.) Flow Characteristics: **Slow**
Deposits: ☒ None ☐ Mud ☐ Sludge ☐ Debris ☐ Grease
Silt Depth: **0** (in.) Deposits Extent:
Infiltration: **None** Pipe Seal Cond: **Sound**

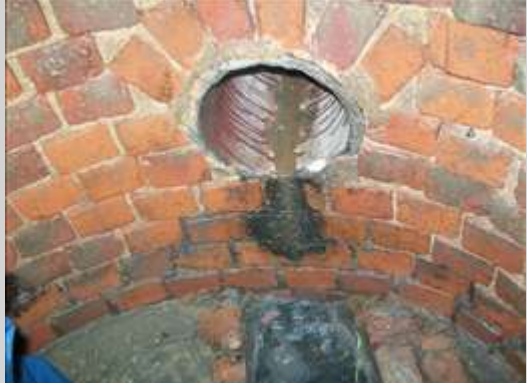
9 O'Clock Inflow

8 in. Circular Gravity Sewer

Pipe In @ 9 O'Clock

Pipe Height: **8.4** (in.) Rod and Bar (Angled)

Infiltration: **None** Pipe Seal Cond: **Sound**
